Article

Evaluating the Effect of the Ecological Restoration of Quarry Slopes in Caidian District, Wuhan City

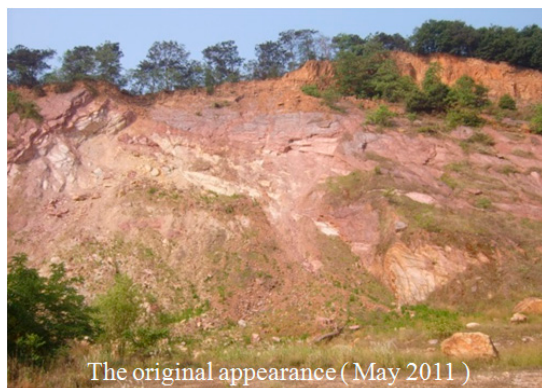
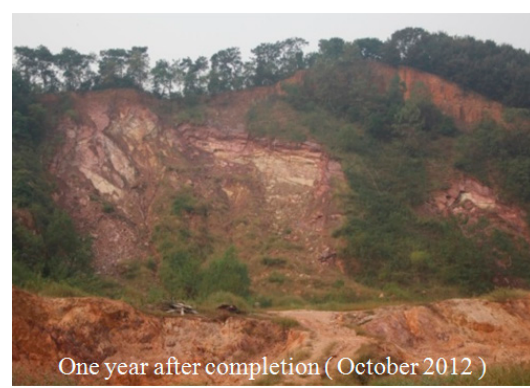
Figure 2. The original appearance and restoration effect on the sample plots. (a) Sample plot I; (b) sample plot II; (c) sample plot III; (d) sample plot IV; (e) sample plot V; (f) sample plot VI; (g) sample plot VII.

It can be concluded from the observational analysis of the seven technologies (Figure 2) that the applications of the TBS galvanized wire complex grass-shrub planting method, CS higher-order granulation technology, tape planting slope technology, and vegetation concrete ecological protection technology for the ecological restoration of quarry slopes in Caidian District were successful, which was worthy of further promotion. However, the soil spray-sowing technology easily collapsed in cases of heavy rain. Because of the complexity and difficulty of construction, as well as the low vegetation
